Massive Sinkhole on Samsen Road in Bangkok

Summary

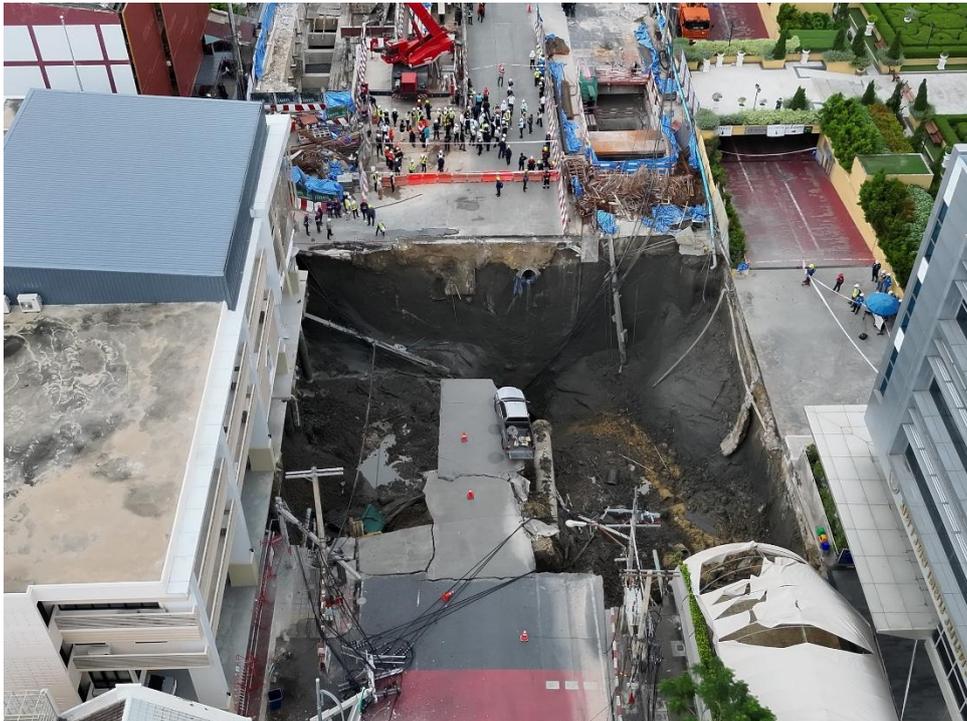
On 24th September 2025 at 7:13 AM, Samsen Road subsided and formed a large hole, approximately 30 meters by 30 meters and 50 meters in depth, from in front of Vajira Hospital to Samsen Police Station. It is the location of the Vajira Hospital Mass Rapid Transport (MRT) metro station, which is part of the south purple line extension. Two electric poles and two cars fell into a cavity. Initially, there were no injuries reported.

Road subsidence (Reference: Facebook: Office of Disaster Prevention and Mitigation)

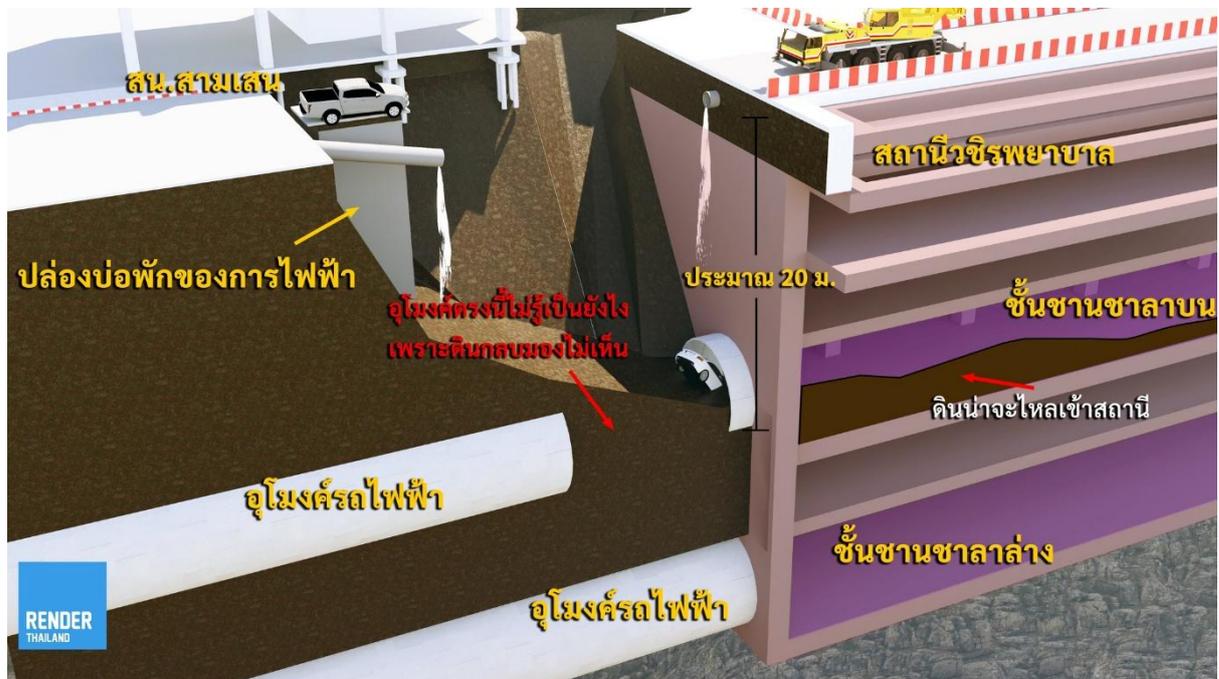
After the subsidence, Mr. Chadchart said the subsidence started from water from waterworks and soil falling into the connection of metro tunnel (15-20 meters in depth) and metro station, which is a weak spot. Some residents saw water seeping from the road before the subsidence. Further root causes are under investigation.

Incident simulation (Reference: Render Thailand)

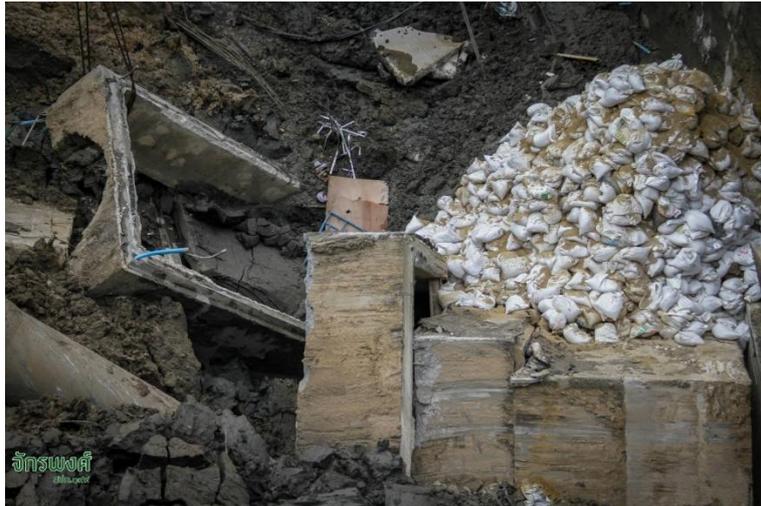
Sealing the tunnel by sandbag

Starting with immediate ground stabilization and water management. Leak point needs to be sealed and reinforcement to stop movement of soil and water into the underground. This involves deploying a large volume of sandbag and concrete pouring to seal off the source of water flow and prevent more soil from the leak point, and locating the leak point to immediately stop water flow. Rainfall is also the concerned point making soil flow easily. Sandbags could be used temporarily to prevent rainwater from entering collapsed areas, which could further destabilize the soil. Related officers conducted all mentioned immediate mitigation to stop further damage.

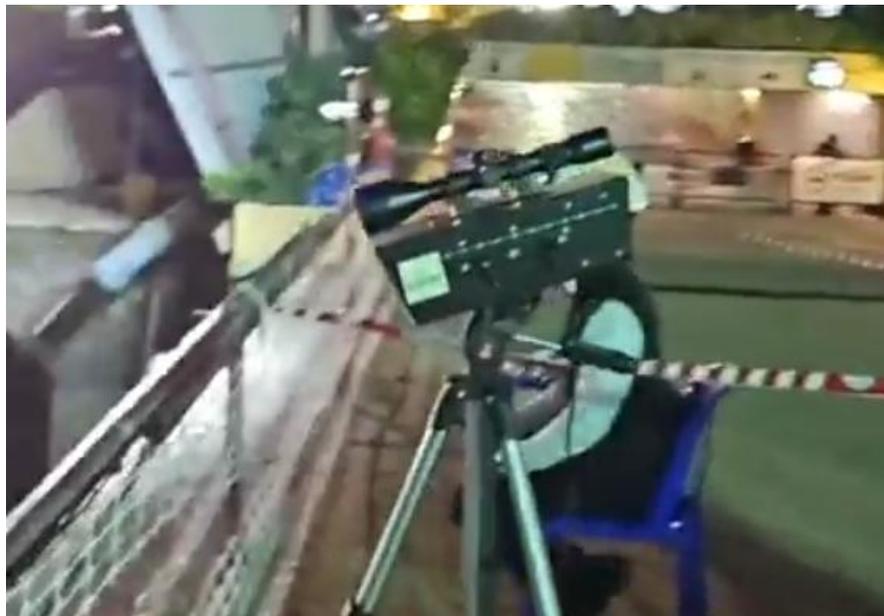
Monitoring tools (Reference: Facebook: Chadchart Sittipunt)

Secondly, Monitoring and assessment should be established all-day for soil movement and ground stability to detect any further subsidence or shifting. Urgently assessing the structural integrity of all surrounding buildings, especially Samsen police station, where foundation piles may have been damaged by the soil. Root cause investigation must be conducted after the immediate mitigation to find the exact sequence of incidents and root causes to prevent recurrence. The officers are investigating the root causes of this incident.
