Massive Sinkhole on Samsen Road in Bangkok

Summary

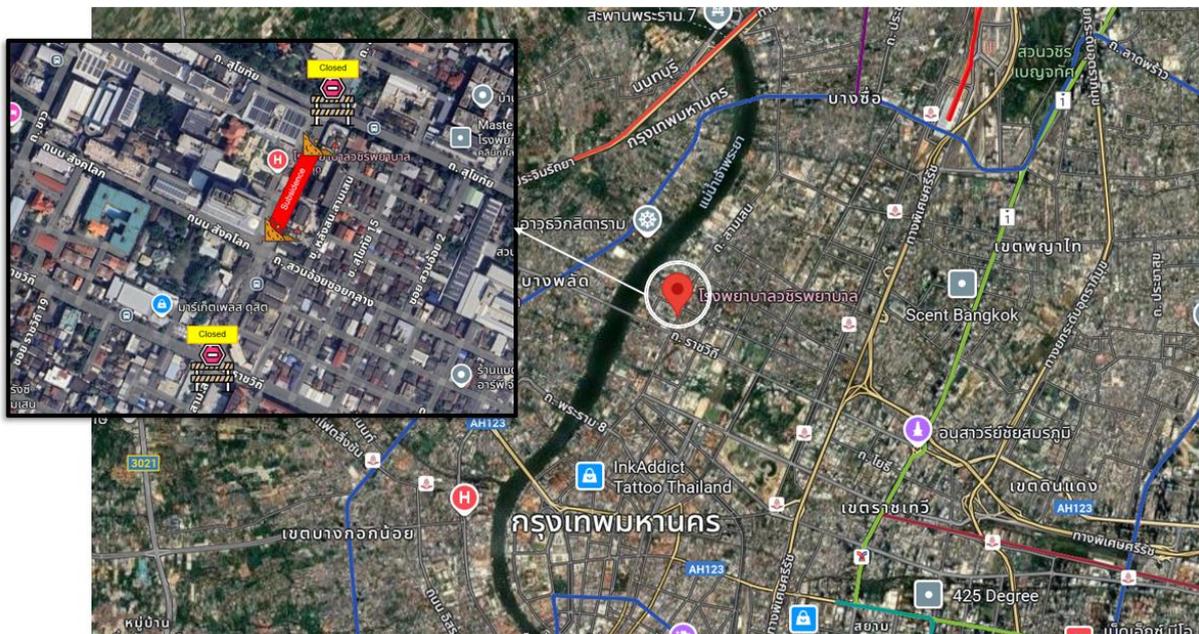
Subsidence location

After the subsidence, Mr. Chadchart said the subsidence started from water from waterworks and soil falling into the connection of metro tunnel (15-20 meters in depth) and metro station, which is a weak spot. Some residents saw water seeping from the road before the subsidence. Further root causes are under investigation.

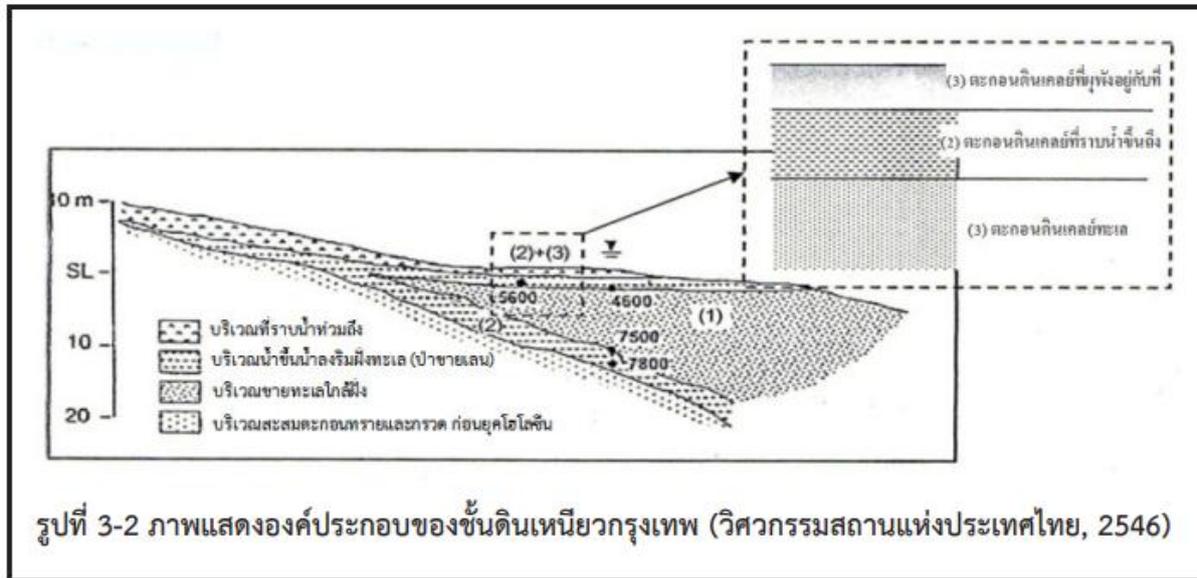
Mr. Pichit, Director-General of the Department of Mineral Resources, explained the incident in terms of mineral resources. “the geological structure of Bangkok is 20 to 30 meters of clay and river delta. A natural cavity cannot happen without external stimulation such as metro construction and leaking underground pipe. Moreover, rainfall causes the erosion of clay structures and becomes a cavity. Water from rainfall and waterwork also dissolves clay and make it easier to flow through a cavity.” So, the geological structure is also main factor of damage. Type of clay in Bangkok is soft clay and river delta. It has unique properties such as high compressibility, high water percentage, low water drainage, shrinkage, expansive and strength. This clay consists of 24 to 30 percent of water. It is called “Bangkok clay”.

Components of Bangkok clay (Reference: Classification of zone for the management of geology and geological resources of Bangkok)
